Repair and Protection of Concrete Exposed to Seawater

By Ali Sohangpurwala and William T. Scannell

This article appeared in the July/August 1994 issue of the *Concrete Repair Bulletin*.

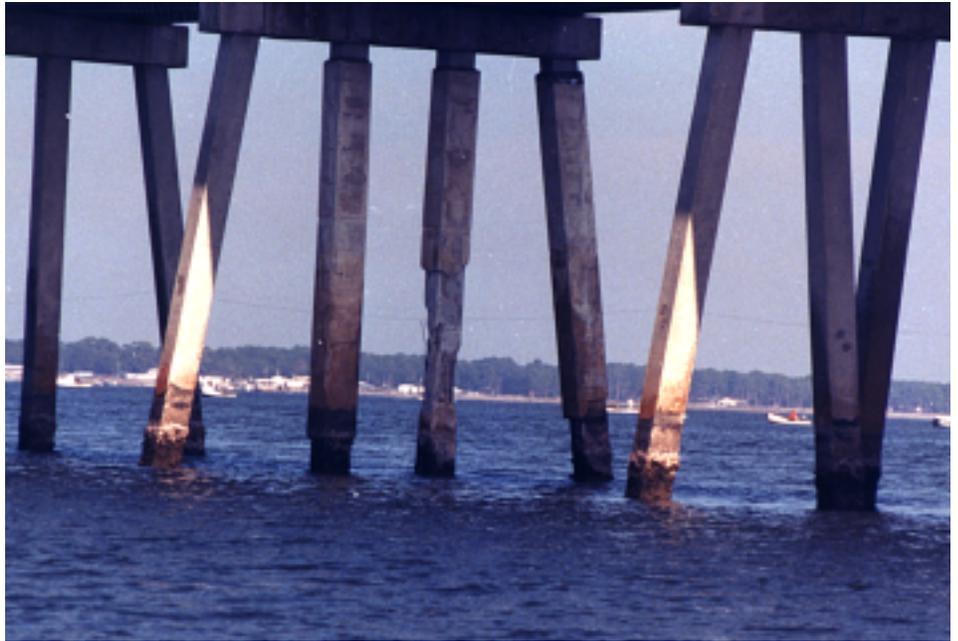
One of the Bryant Patton Bridges in Florida displays a reinforced concrete pile with significant corrosion induced damage.

The detrimental effects of pile jacketing for corrosion protection are exemplified by the Bryant Patton Bridges in Florida. A 1990 survey of the piles conducted by the Florida Department of Transportation showed that 50% of the piles that were found to be deficient had previously been repaired with fiberglass jackets. In some cases, construction

defects were found in the jackets. A rehabilitation project was initiated in 1993 and jackets from numerous piles were removed. Almost all piles which had been jacketed showed significant corrosion induced damage. Due to the severity of the damage, the Florida Department of Transportation decided to install supplementary replacement piles (crutch bends) to each and every pile which had been jacketed.

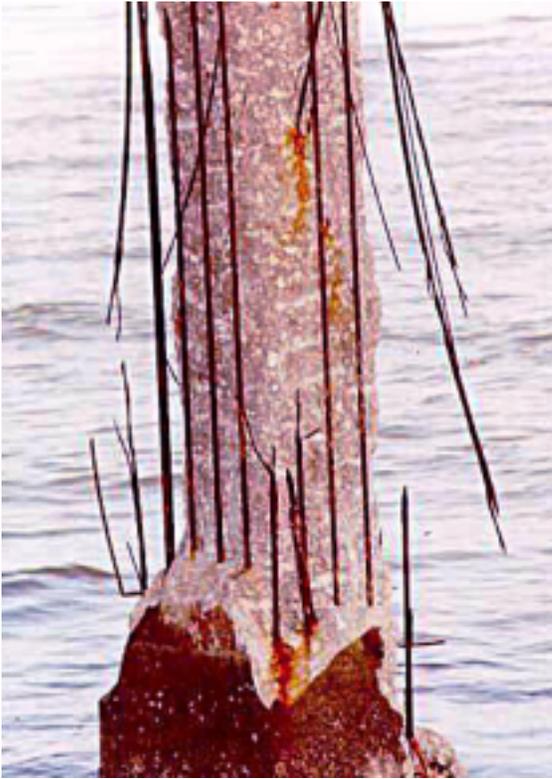
A severely deteriorated pile which had previously been repaired with a fiberglass jacket.

been used to manufacture jackets and the filler material has varied from sand/cement mortars to synthetic polymers. It was believed that the jackets would provide protection against future corrosion damage. However, it turned out that jackets were powerless against corrosion for a number of reasons. First, capillary action allowed water from the submerged section of the pile to rise up the pile. Also, high levels of chloride ions remained in unrepaired areas. Although jackets could delay additional chlorides from entering the pile through the jacket surface, they did nothing to mitigate corrosion of the reinforcing steel. In fact, it has been shown that jackets accelerate the corrosion process in pilings since the concrete is never allowed to dry out and sufficient oxygen is always available in the jacketed area. Unfortunately, the only thing a jacket can do is keep corrosion induced damage out of site which, as discussed below, can prove to be more dangerous than ignoring the problem altogether.

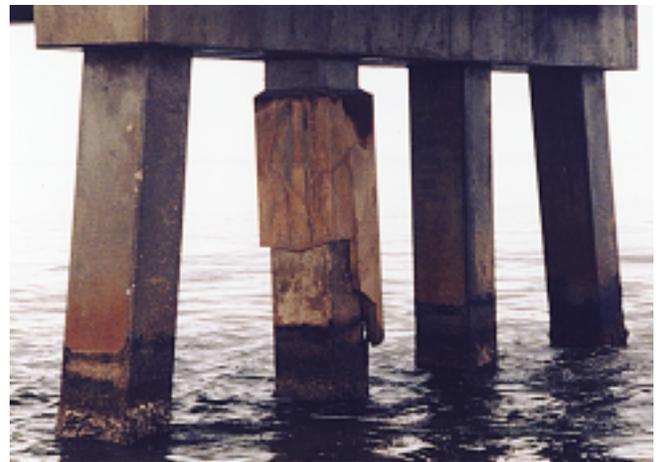
Failure of a non-structural pile jacket.

Another kind of conventional repair involves the use of “jackets.” There are two broad categories of jackets; structural and non-structural. Structural jackets are used to repair structural damage and non-structural jackets are typically used when dealing with corrosion induced damage. The discussions that follows pertain to non-structural jackets only. This type of repair has been used on bridge pilings and several different kinds of jackets have been used to date. Materials such as wood and fiberglass have

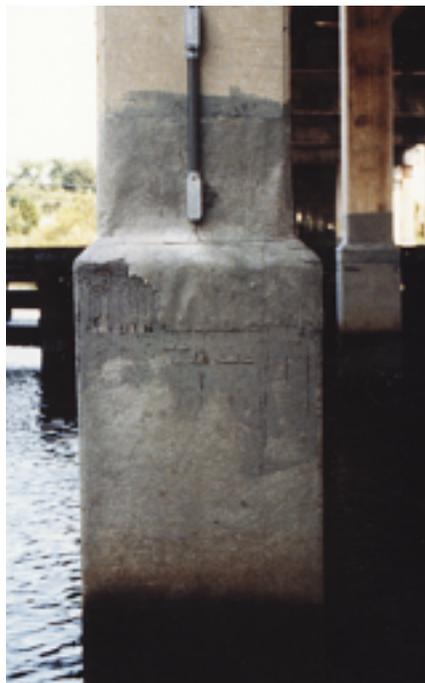
The integral pile jacket system uses a fiberglass jacket supplied with the mesh anode.

The second system is called an integral pile jacket system. This recently developed system utilizes a prefabricated fiberglass jacket which is supplied with the mesh anode already in place. The jacket system is mounted to the pile using compression bands and then the void between the jacket and the concrete surface is filled with a grout.

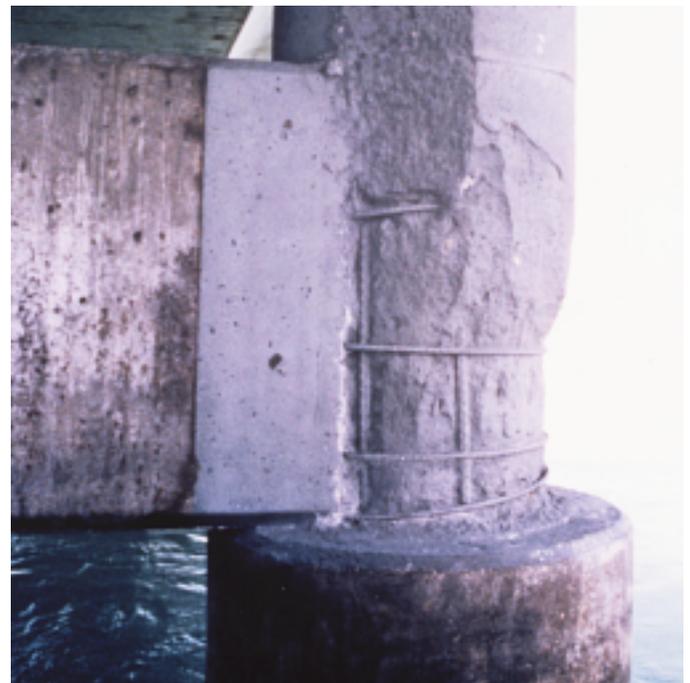
A thin layer of zinc is applied directly to cleaned steel and adjacent concrete surfaces as part of the galvanic system.

Presently, there are three non-encapsulated bridge piling systems. The impressed current system is called the conductive rubber jacket system. A corrugated conductive rubber material is attached to the concrete surface. Intimate contact is achieved by fiberglass panels and compression bands. This system can be designed to protect the tidal and splash zone on bridge pilings in a marine environment. Another system utilizes perforated zinc sheets to provide galvanic protection in the tidal and splash zone. Recycled wood/plastic panels with cut grooves on the contact face are used in lieu of fiberglass panels. Installation is very similar to the conductive rubber system except extensive electrical wiring and an external power source are not required. The final system,

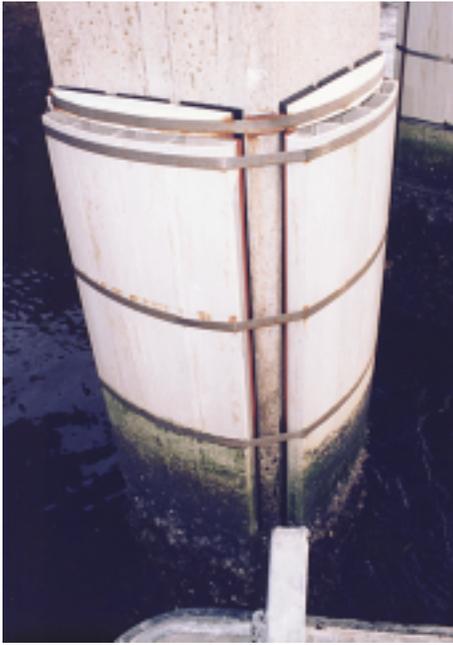
This conductive rubber jacket system is protecting the tidal and splash zones of a bridge piling.
